Example of a Conceptual Site Model and Site Summary – completed and submitted prior to Scoping Meeting Conceptual Site Model and Site Summary for XXXX Site (DE # XXXX)

The purpose of the Conceptual Site Model and Site Summary (CSM-SS) document is to provide a single document where all the information about the site can easily be reviewed and used for decision making at any stage of the project. This format is all inclusive and not all sections are applicable to all sites. The CSM-SS is a dynamic document that is intended to be refined and updated as new information becomes available.

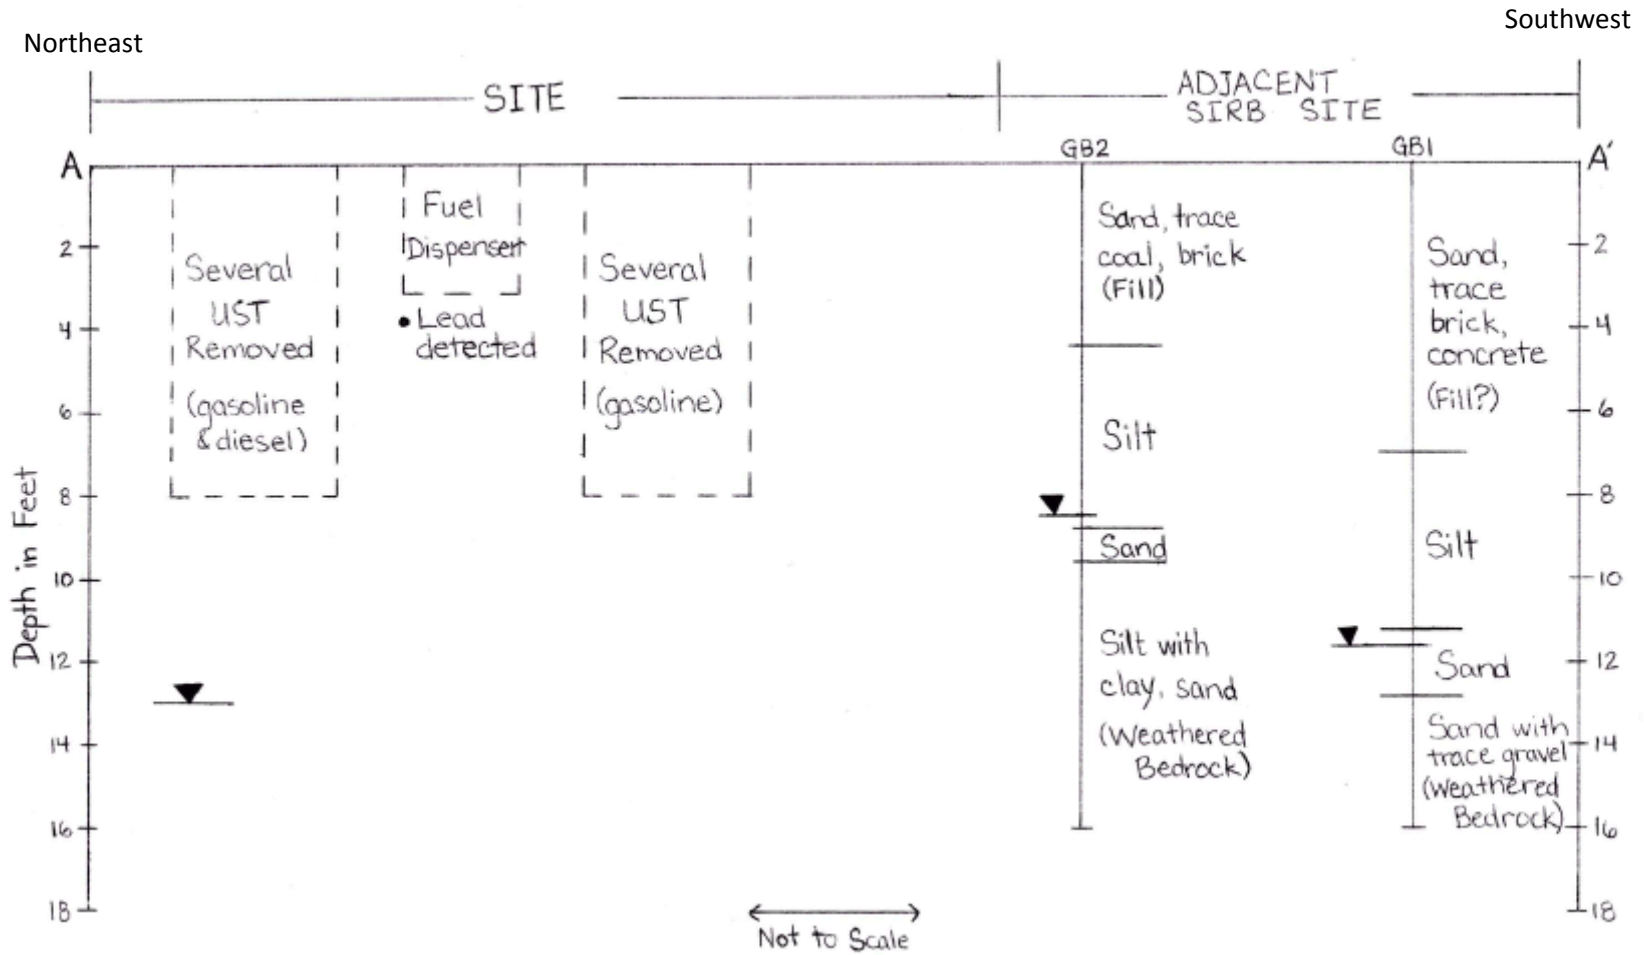
16.3 Conceptual Site Model (Cross-sectional View) [Back to Table of Contents](#)

SECTIONS	DESCRIPTION	COMMENTS	MAPS, PHOTOS & TABLES	REFERENCE USED
6.1 Regional Geology	<ul style="list-style-type: none"> • Located in the Appalachian Piedmont Physiographic Province. • Approximately 1.8 miles north of the Fall Line separating the Piedmont and Coastal Plain Physiographic provinces • Poorly sorted fine-to-coarse grained sand, as well as possible interbedded silt, clay, gravel and cobbles. • Adjacent DNREC-SIRB site well logs indicate sand layer at ~11 feet and weathered bedrock at ~16 feet. 		Maps CSM Cross-section (see 16.3)

6.2 Site Geology		Update this section after the investigation		
6.3 Regional Hydrogeology	<ul style="list-style-type: none"> • Groundwater generally flows toward the south. The depth of groundwater is estimated at approximately 12 feet below ground surface. 		CSM Cross-section (see 16.3)	<i>Geohydrology of the Wilmington Area, Hydrologic Map Series, Number 3</i>

Note: See above drawing for approximate location of A and A'

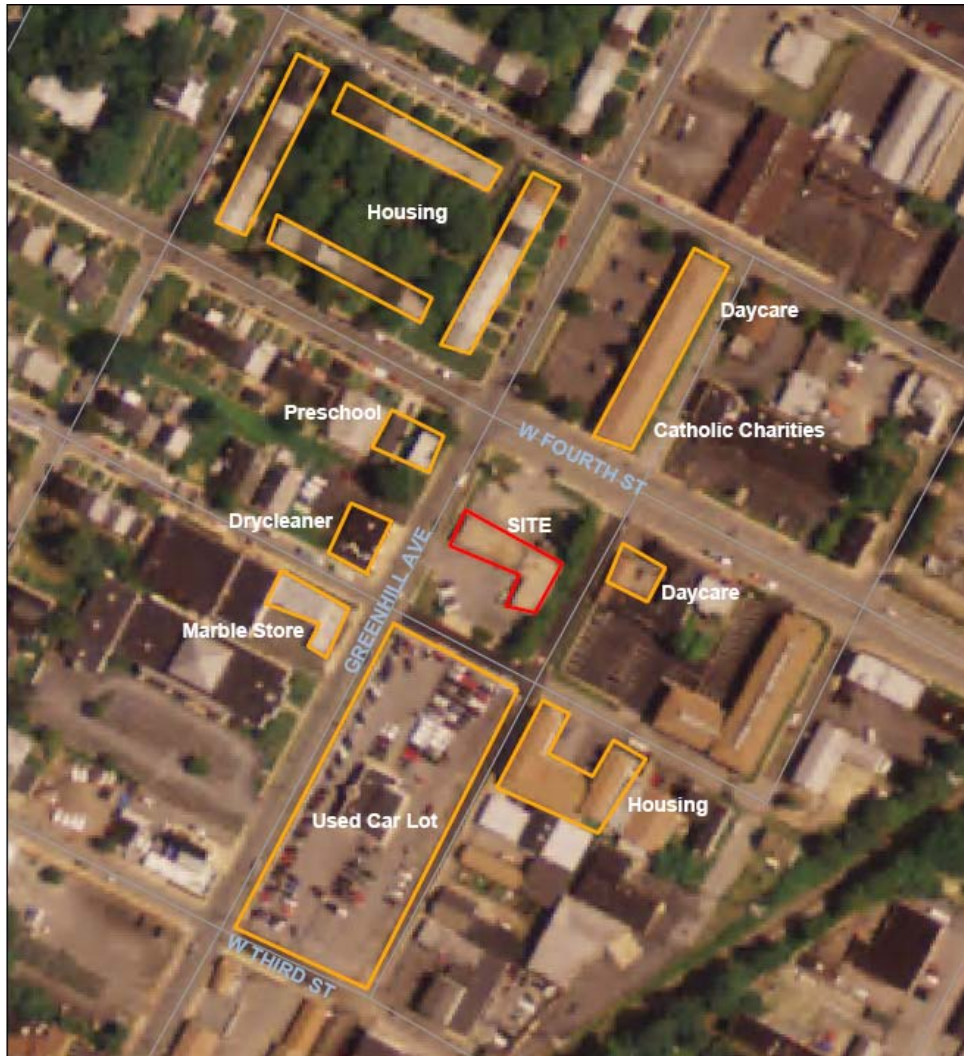
Aerial Photo (2006) and Adjacent Property Map

SECTIONS	DESCRIPTION	COMMENTS	MAPS, PHOTOS & TABLES	REFERENCE USED
<i>5.1 List all adjacent site land uses(past & present)</i>	<p>Current</p> <ul style="list-style-type: none"> • Dry cleaner (301 Greenhill Ave) • Catholic Charities of the Diocese of Wilmington (2601 W. 4th St) • Hawley Plaza (daycare, learning center, restaurant, pub) • Two daycares and a paved parking lot • Residences & private garages • Diver’s Used Vehicle Sales (210 Greenhill Ave) • Mohawk Tile & Marble <p>Historic</p> <ul style="list-style-type: none"> • 210 Greenhill Site, part of the Wilmington Leather Company, is nearby. 	E=	Adjacent Property Map (See Appendix)	Phase I ESA
<i>5.2 Describe any known or potential contaminant sources on adjacent sites.</i>	<ul style="list-style-type: none"> • Catholic Charities – UST and LUST site • Diver property – DE# 1080, SHWS, UST and LUST site • Dry cleaner – Drycleaner site, Air Emission Listing, RCRA-SQG, FINDS and PA Manifest site 			Phase I ESA

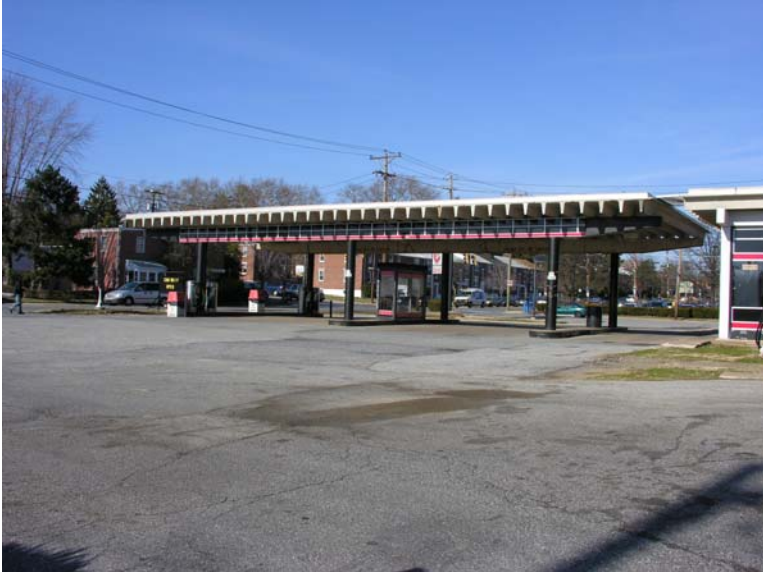
Canopy that previously covered gas pumps

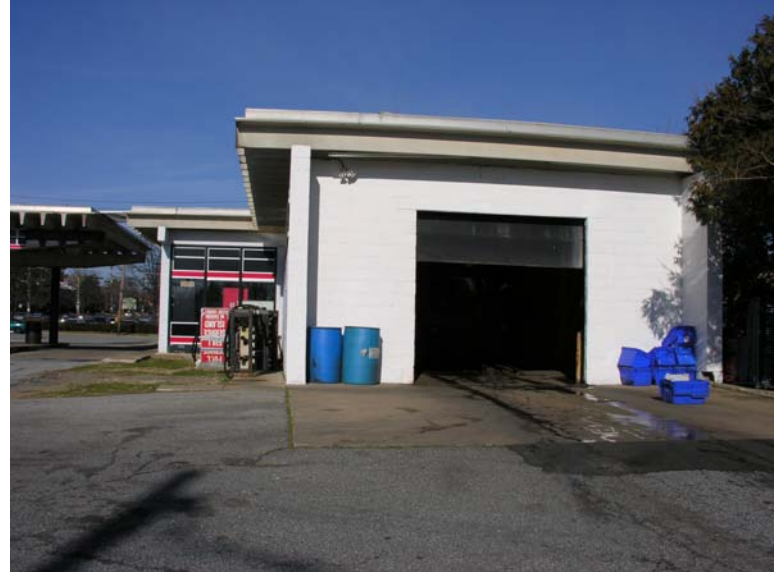
View of carwash exit
